"Successful Completion of the RBMK-1500 Defueling Project at the Ignalina Nuclear Power Plant: Experience and Expertise Gained"

26 September 2022

Ignalina NPP - general information

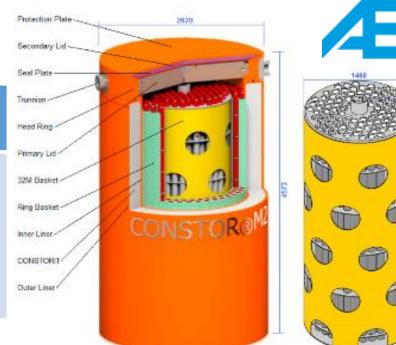
Cask CONSTOR® RBMK-1500/M2

To ensure safe loading & long- term storage for SF:	To withstand internal and external events:
 Capacity: 91 SFA Height: 4520 m, diameter: 2628 mm Empty cask: 90 t; fully loaded: 118 t Heating capacity (max.): 12,55 kW Sub-criticality: < 0.95 Max. doze rate at surface: 1.0 mSv/h 	 Fire accident: 800 C for 30 min and 600 C for 1 h Drop accident: 9 meter Seismic event: 8 grades (MSK-64 scale) Aeroplane impact

Interim Spent Fuel Storage Facility:

Max surface temperature (calc.): 91°C

- Storage Hall capacity: 202 casks
- Cask Service Station: 2 welding platforms
- Fuel Inspection Hot Cell: for inspection and repackaging of the spent nuclear fuel
- Heat dissipation natural convention
- Max. dose rate for population at security fence: 0,2 mSv/year
- Seismic event: 8 grades (MSK-64 scale)

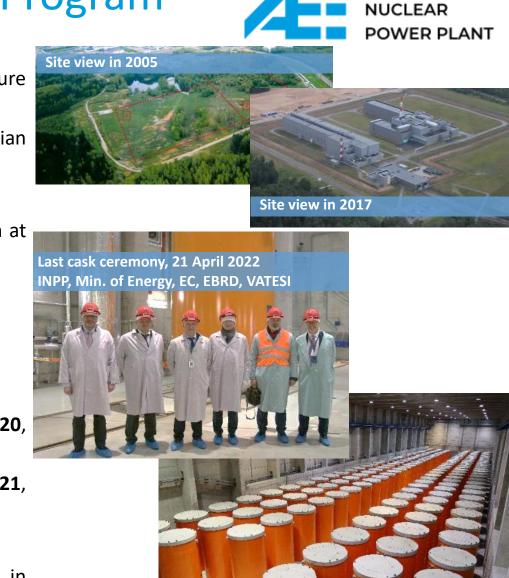
Fully loaded ISFSF Storage Hall
